Is there really allergy to the cement in hip and knee arthroplasty?

Seidel P*, Williamson A*, Weber AT#

* Heraeus Medical GmbH, Philip Reis Strasse 8-13, 61273 Wehrheim

XXXIVth GECO Grand Conference

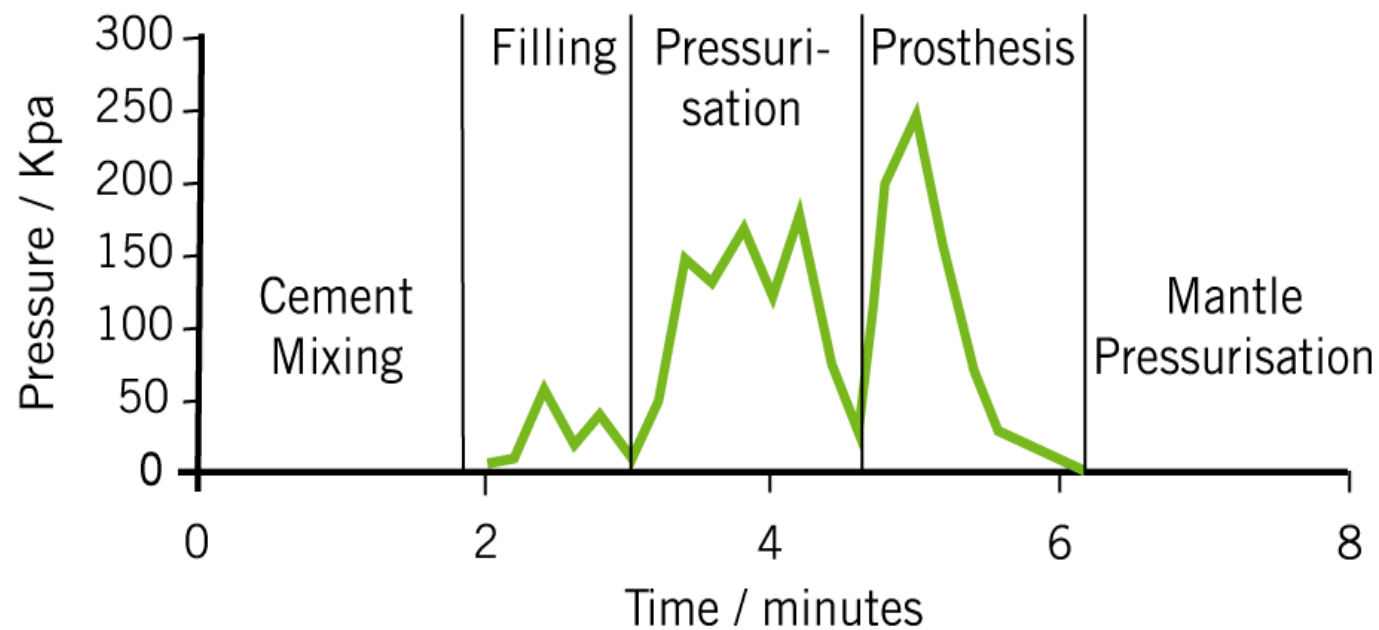
Schematic pressure profile for a total hip implant

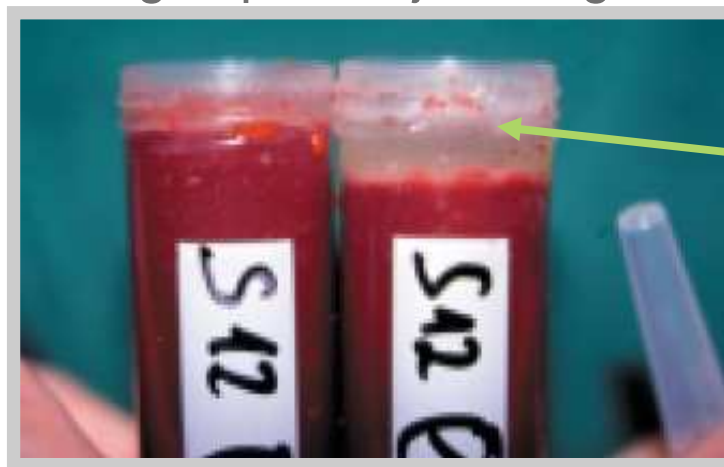
- ▶ The amount of fat, bone marrow and blood clots passed into the venous draining system of the femur is significantly reduced by using a pulsed jet lavage cleaning system

fat in supernatant

Comparison of blood from the iliac veins collected during and after simultaneous cementation of both sheep femora. **Left:** femoral canal cleaned with jet lavage, **Right:** femur canal cleaned with a syringe with identical washing volume

The risk for fat embolism is reduced by jet lavage

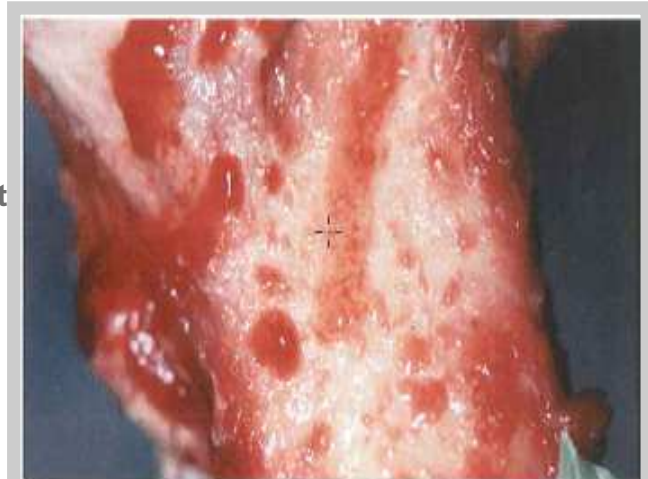
Fig. 15.11. Visible fat extrusion at the anterior aspect of the proximal femur during implantation of the femoral prosthesis

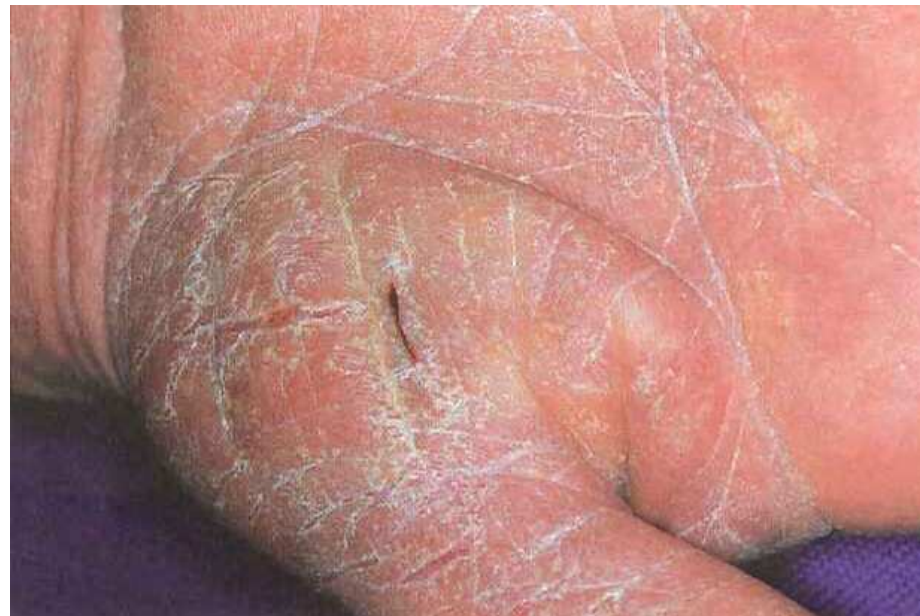
- ▶ Hand exczema of an acrylate hypersensitive dentist

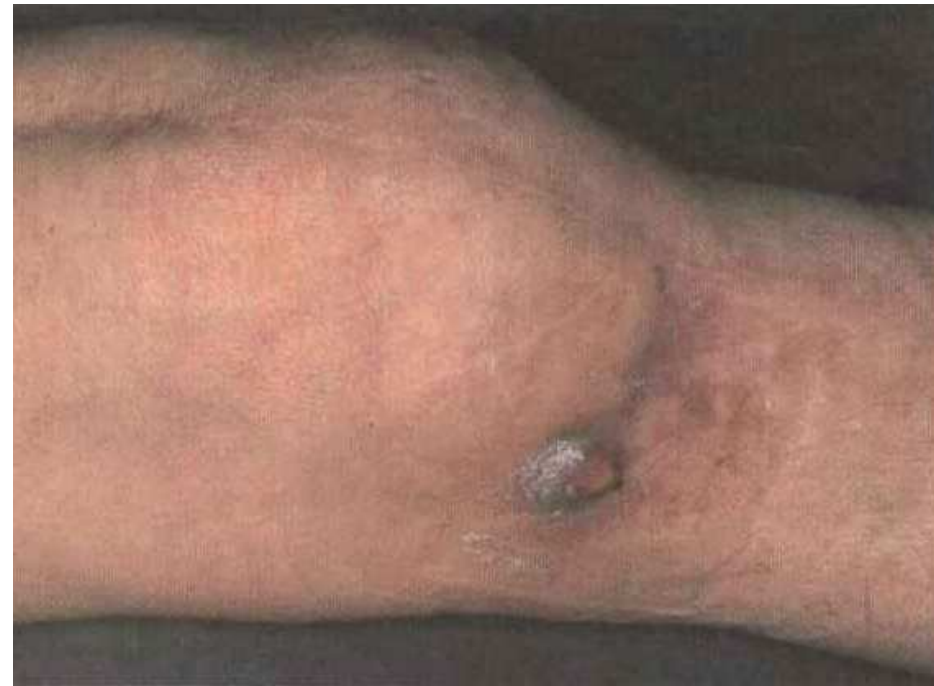
- ▶ Contact dermal exczema and fistula formation based on gentamicin, MMA and Ni/Cr – contact allergy
